Geology, Soils, and Seismicity

This section of the EIR presents a description of the existing geology, soils, and seismic conditions in the project area and analyzes potential physical environmental effects of the proposed project related to seismic hazards, underlying soil characteristics, slope stability, erosion, and excavation of soils.

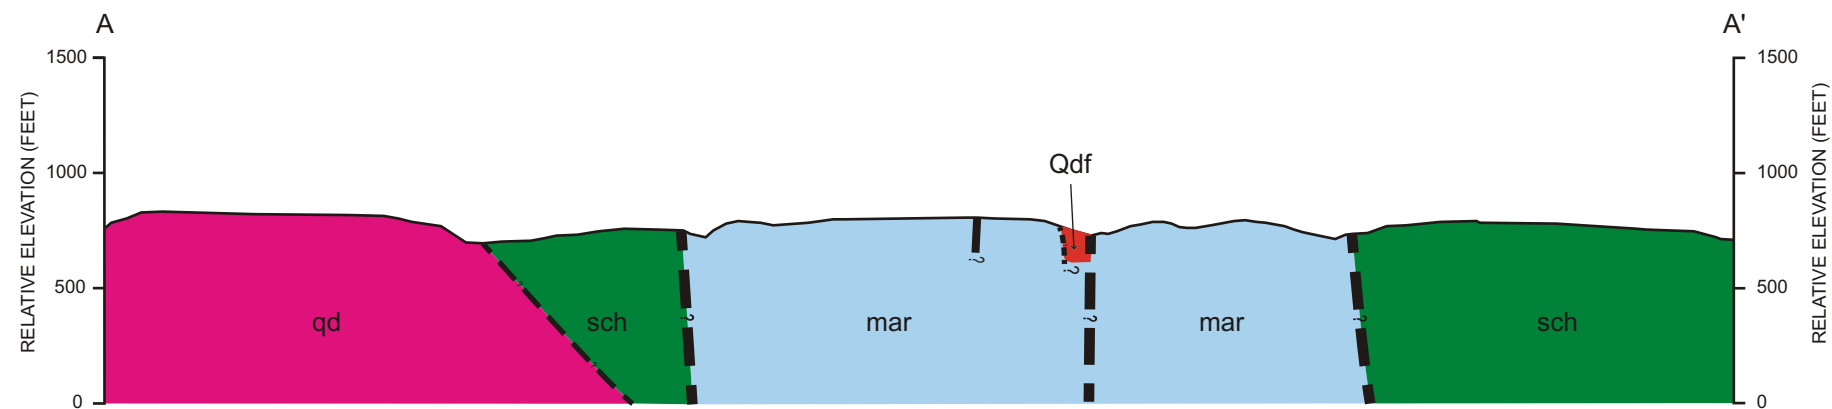
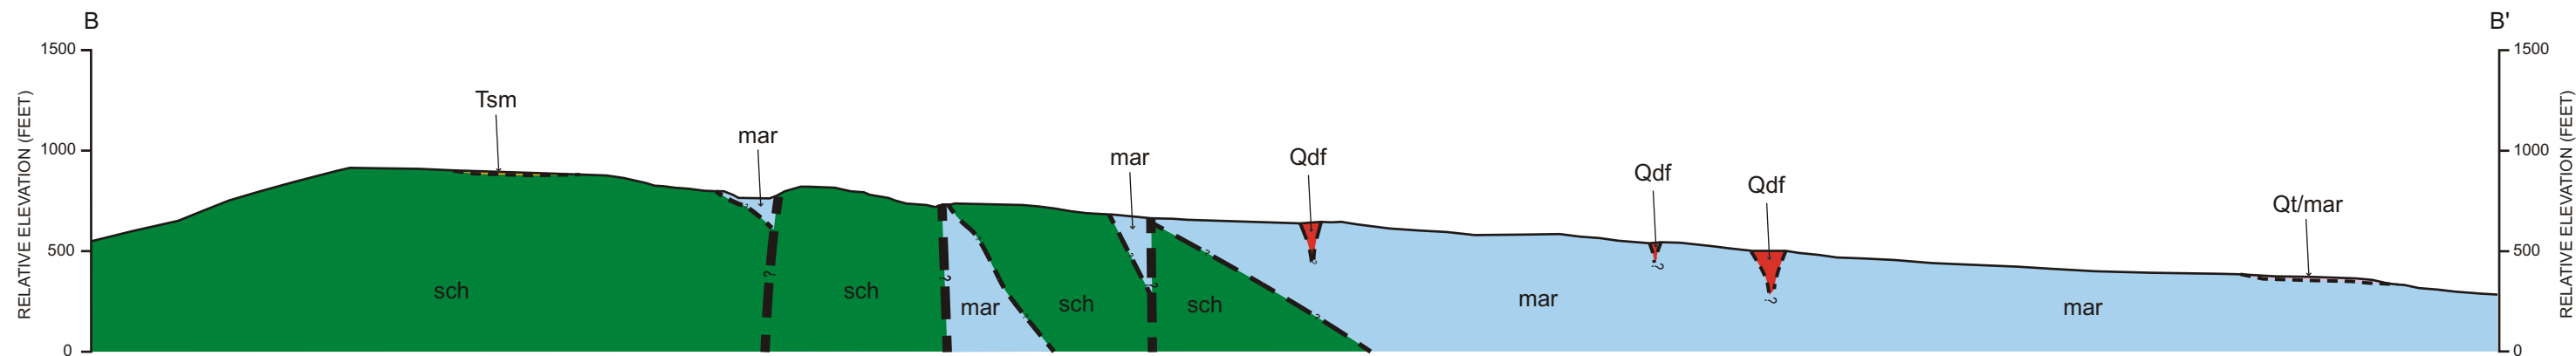
FIGURE 4.6-5

CROSS SECTION A-A'

CROSS SECTION B-B'

Note:
See figure 4.6-4 for an explanation of symbols and units.
