## 3.10 HYDROLOGY AND WATER QUALITY

This section describes the existing hydrology and water quality conditions for the LRDP area and analyzes the potential for the 2021 LRDP to affect water quality, including resulting in substantial siltation or erosion, cause flooding due to the alteration of drainage patterns, or to deplete groundwater supplies or interfere with groundwater recharge.

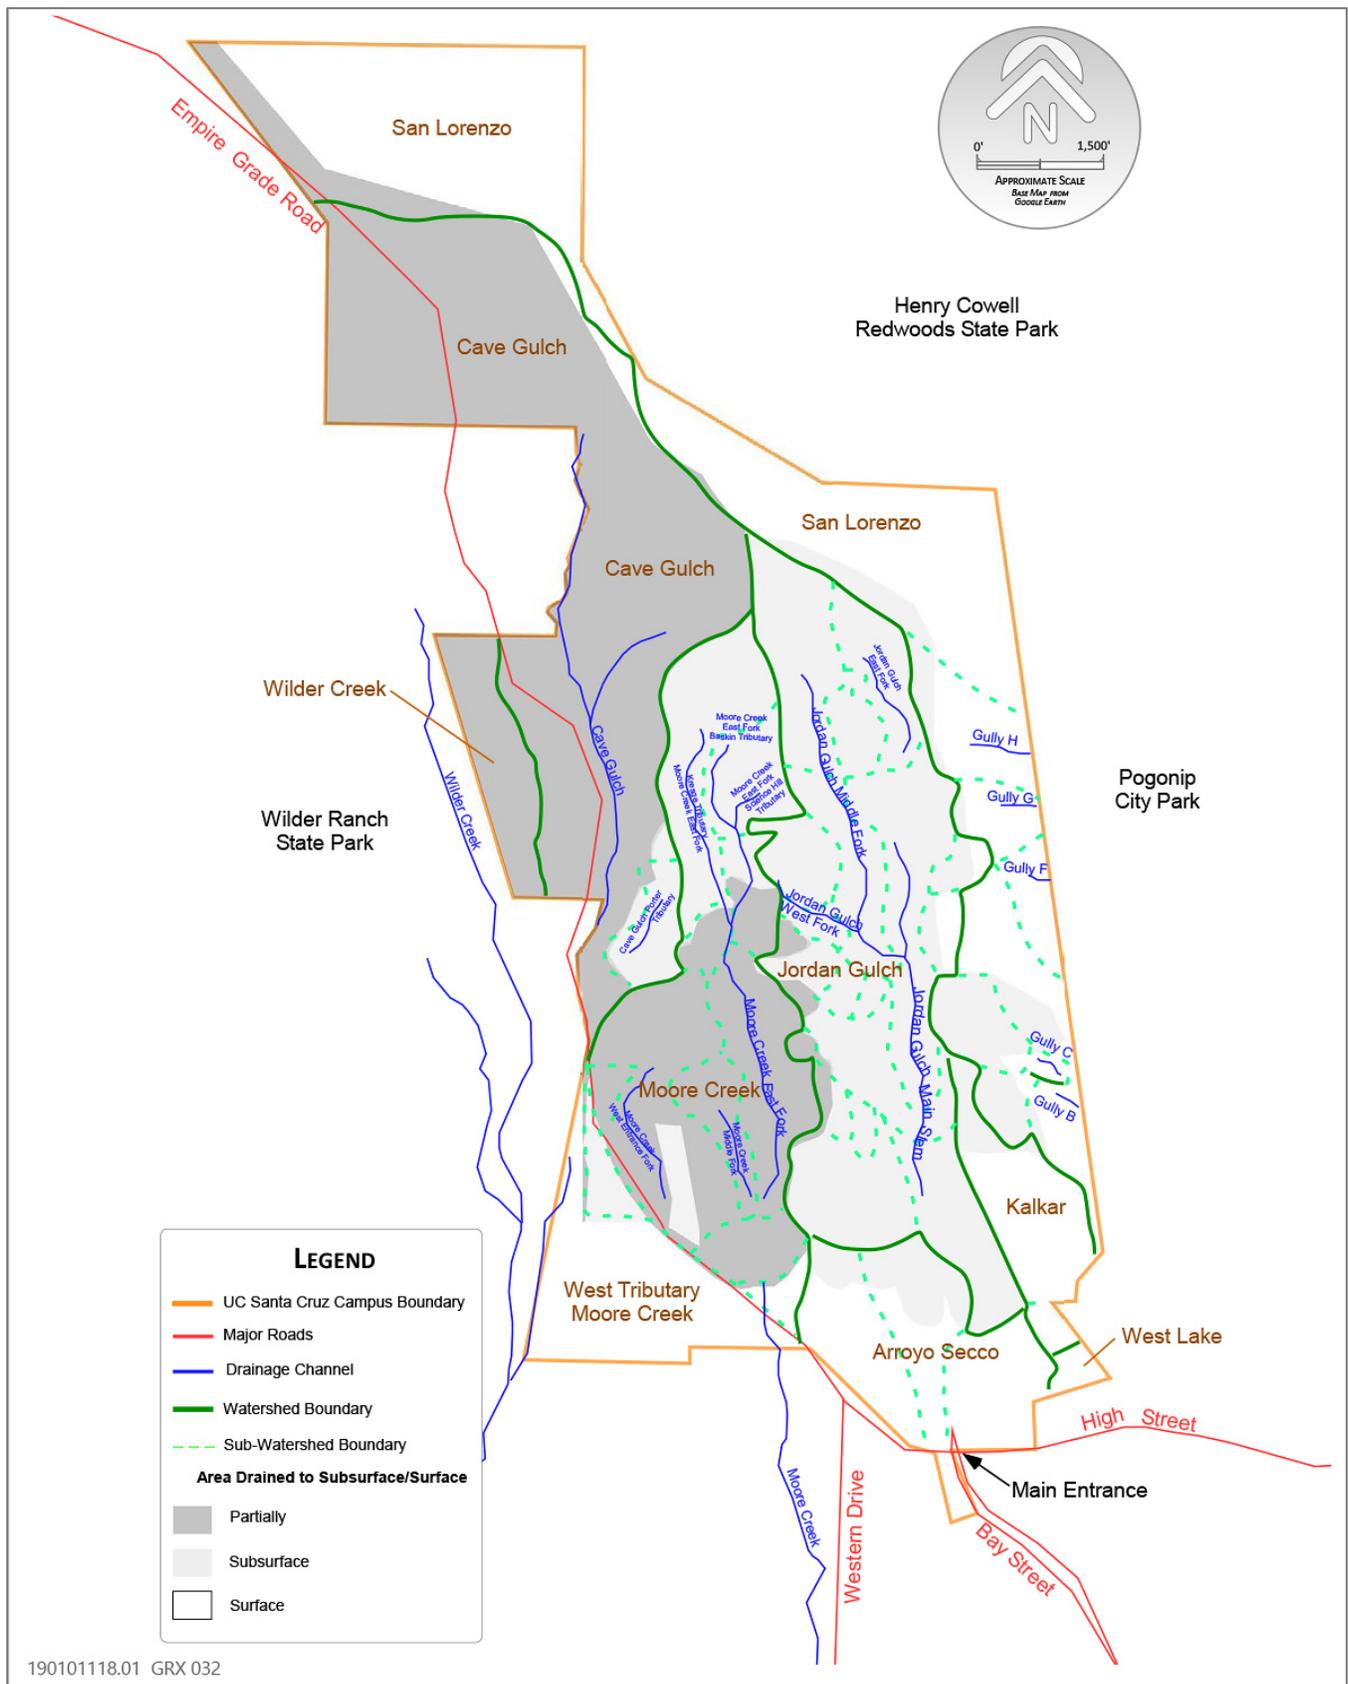
Figure 3.10-1 Watersheds and Sub-Basins on UC Santa Cruz Campus

Source: Figure produced and provided by Weber, Hayes & Associates in 2020

Three watersheds, Cave Gulch, Moore Creek and Jordan Gulch, drain approximately 1,275 acres in the northern and central portions of the main residential campus. All three stream channels are generally aligned north-south and controlled by the major geologic fracture systems on the main residential campus. Cave Gulch, which drains mainly the undeveloped northwestern portions of the main residential campus, joins Wilder Creek immediately west of the main residential campus. Moore Creek, which drains the central and western portions of the main residential campus, flows in a southwesterly direction and ultimately discharges into Antonelli Pond near the coast. Jordan Gulch drains the central and eastern portions of the main residential campus and much of the developed campus core and continues as a spring-fed channel down Bay Street (Figure 3.10-1).

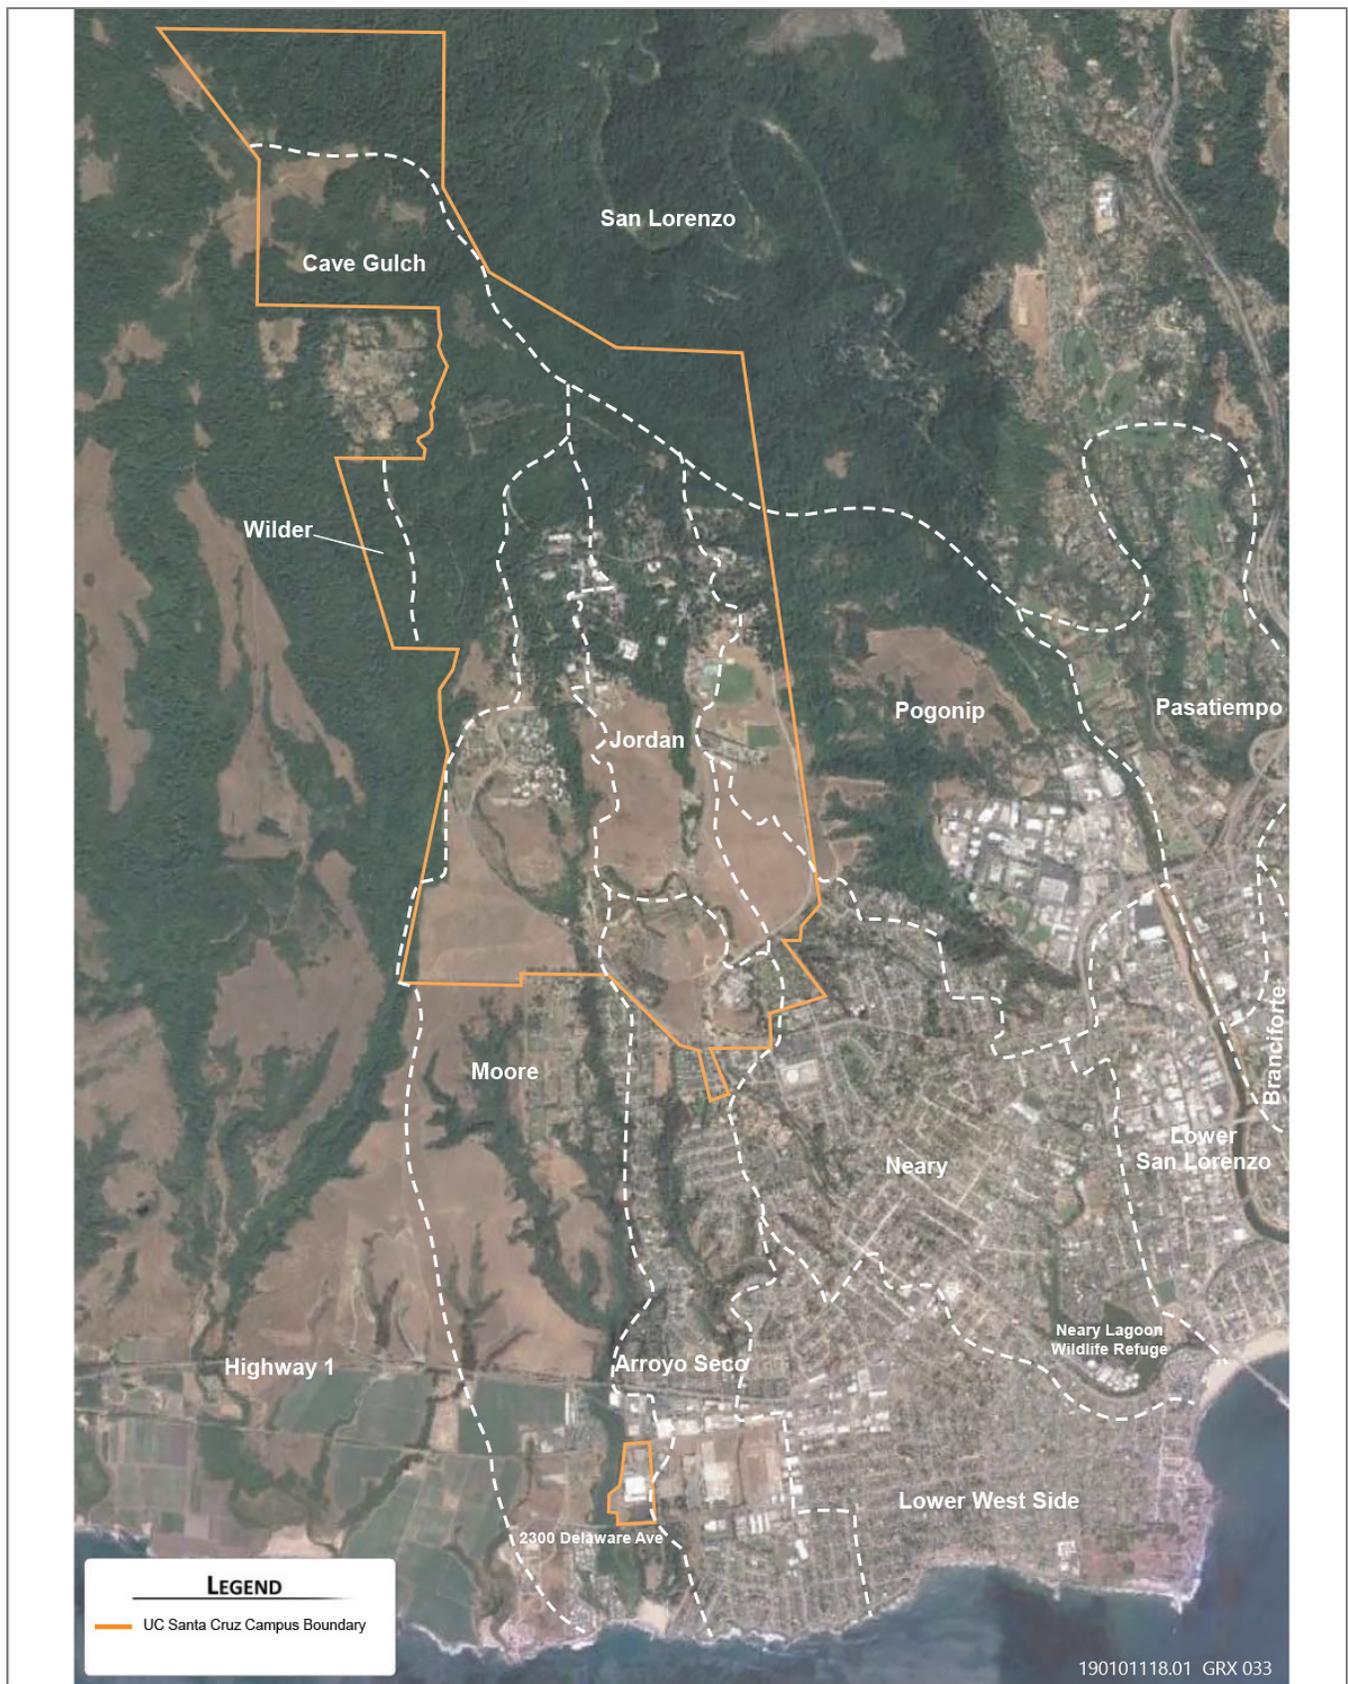
**Figure 3.10-2 Watersheds in the Greater Vicinity of UC Santa Cruz Campus**

Source: Figure produced and provided by Weber, Hayes & Associates in 2020

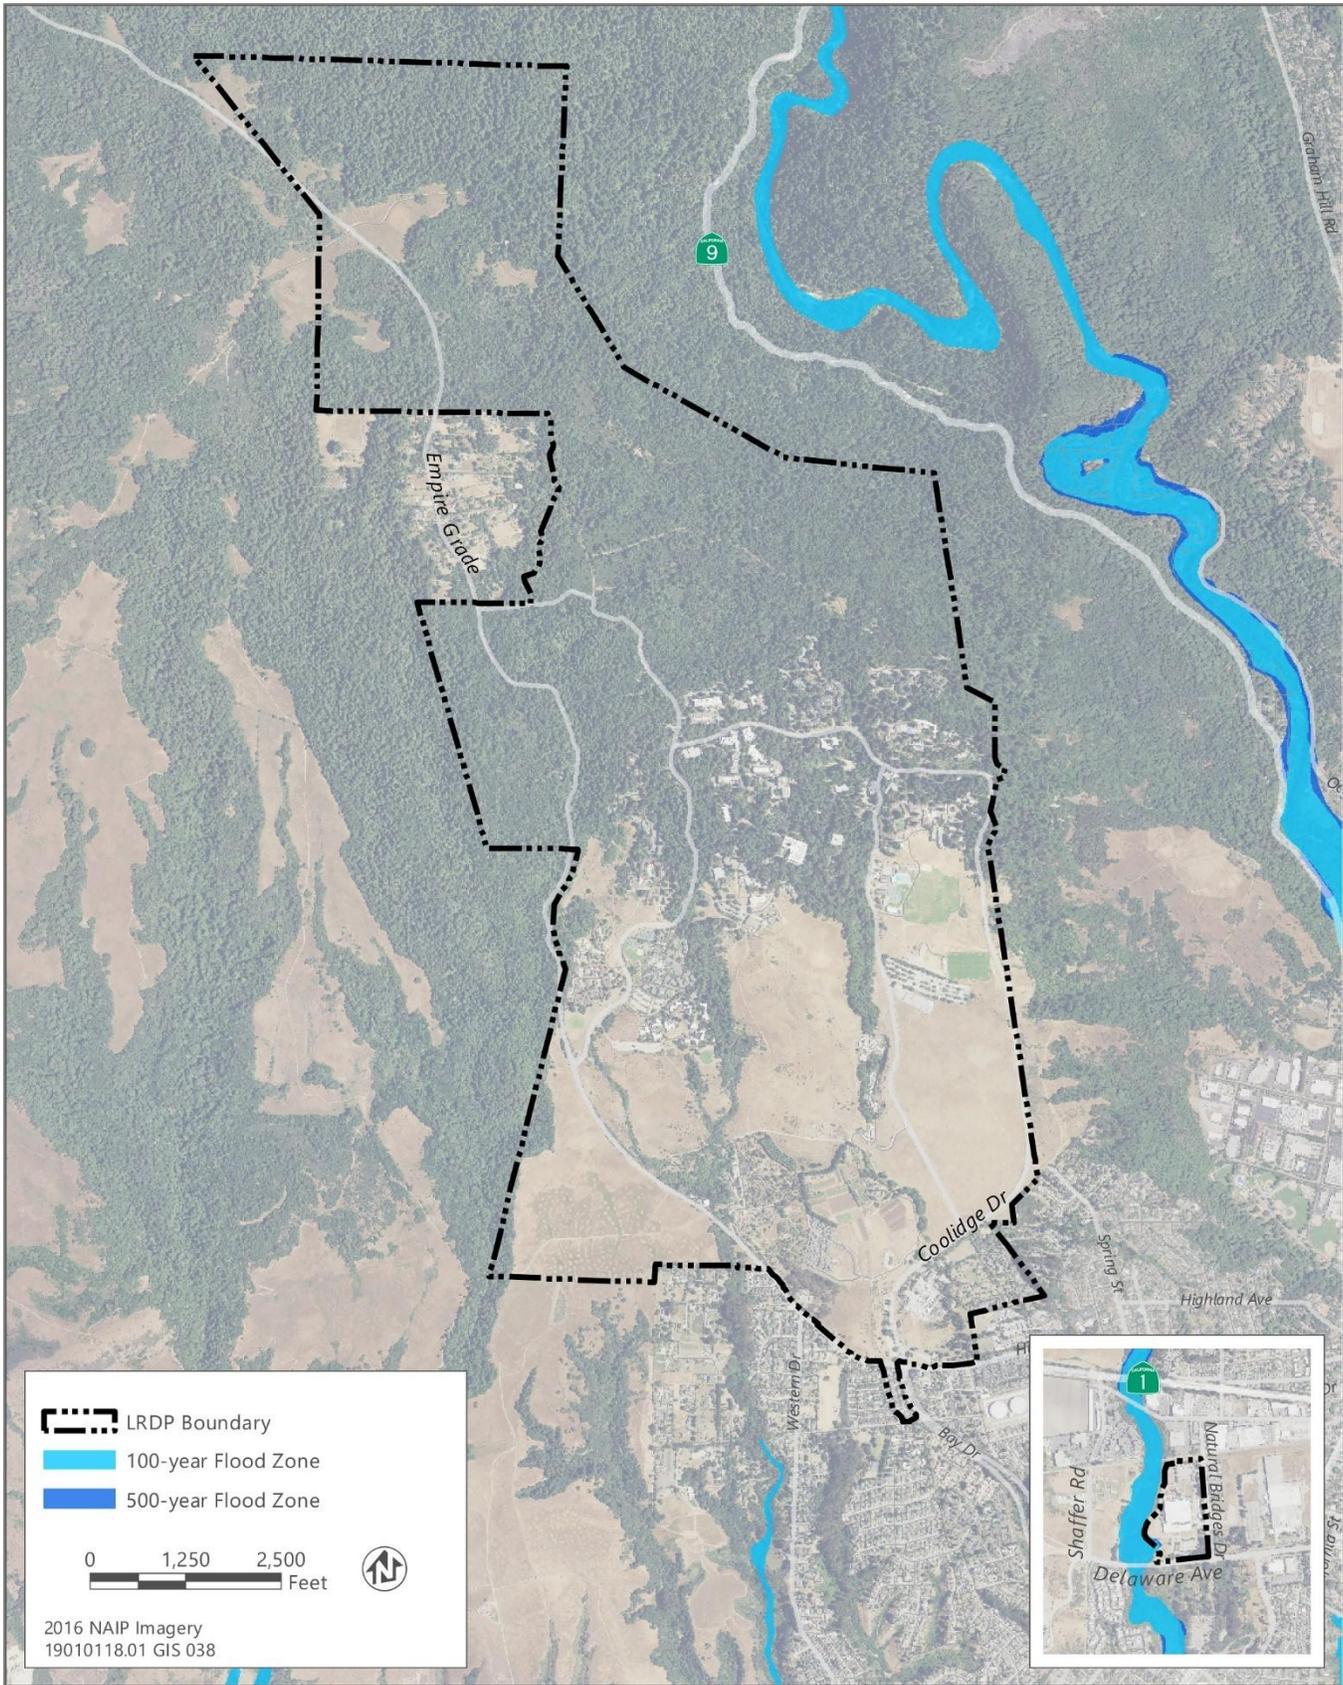
Figure 3.10-3 Flood Zones

Source: data downloaded from FEMA in 2020

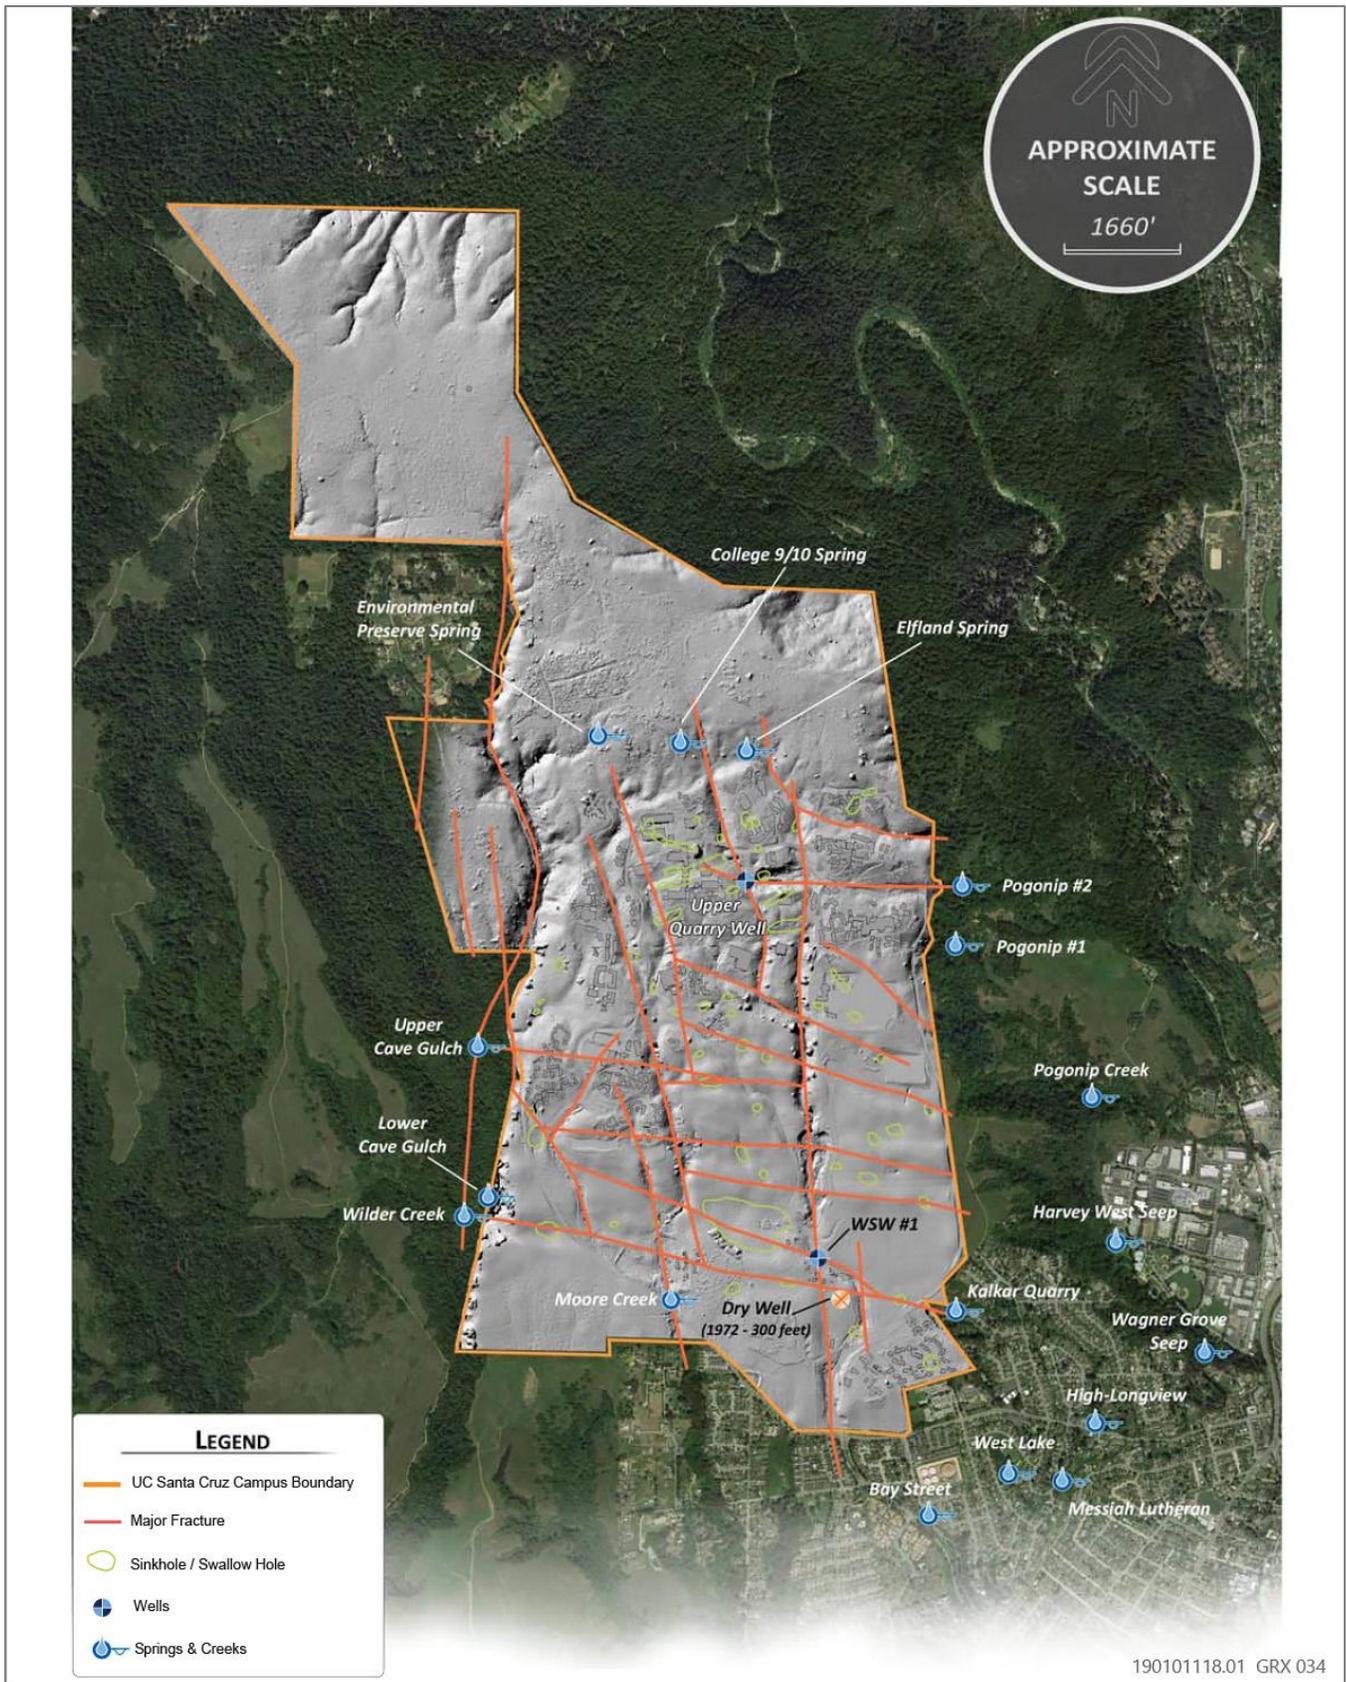
Figure 3.10-4 Major Fractures on the UC Santa Cruz Campus

Source: Figure produced and provided by Weber, Hayes & Associates in 2020

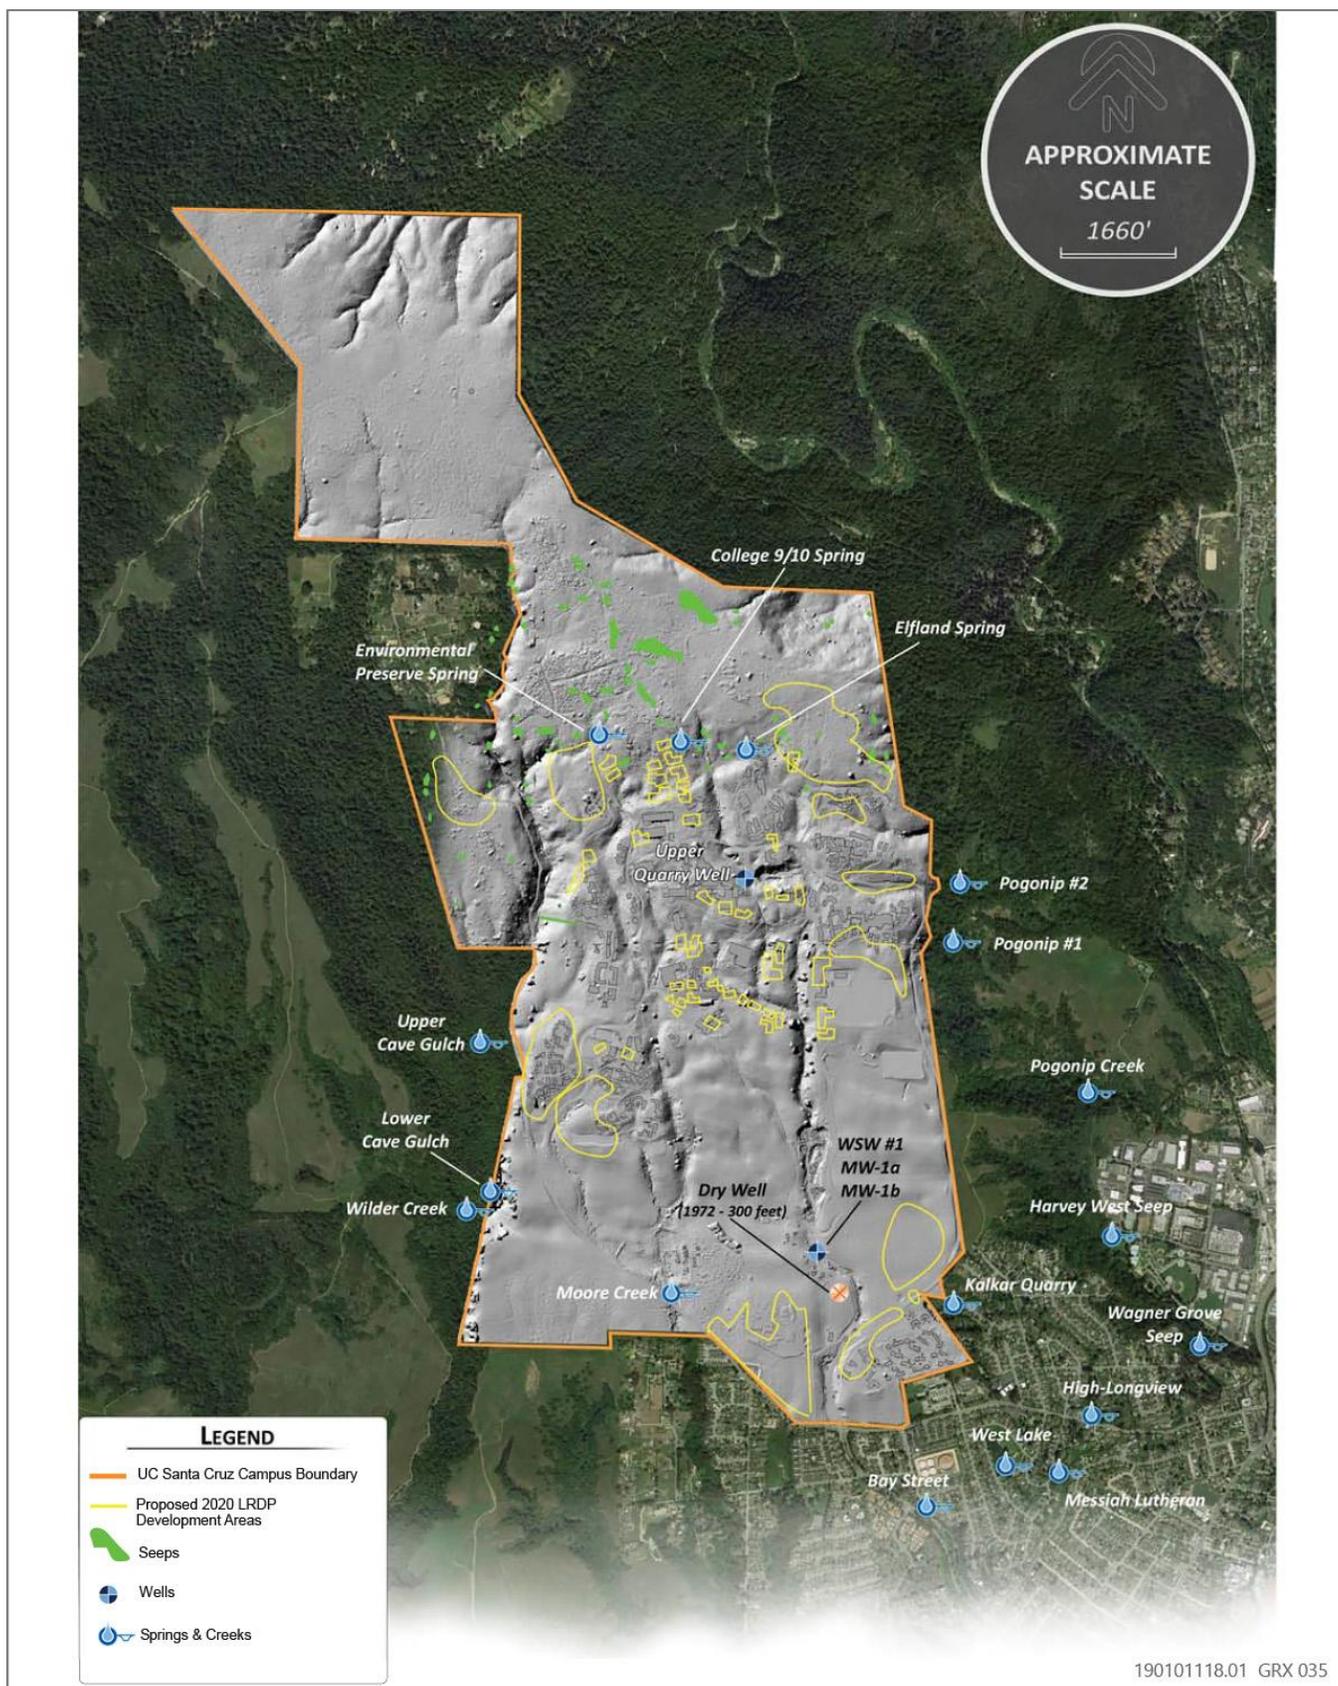
Figure 3.10-5 Mapped Springs and Seeps on and Surrounding UC Santa Cruz and On-Campus Wells

Source: Figure produced and provided by Weber, Hayes & Associates in 2020
